## Construction of Ice Domes at Asuka Station in Antarctica

**Abstract:** An attempt was made to construct an ice dome in order to study the construction technique and to examine its deformation by creep and sublimation of ice in the Antarctic. A 10-m diameter membrane was inflated by a ventilator. Stored water was sprayed on it, and sometimes milled snow was blown by a small snow miller. About 13 t of water was consumed for making an ice dome 7 cm thick, 3 m high.

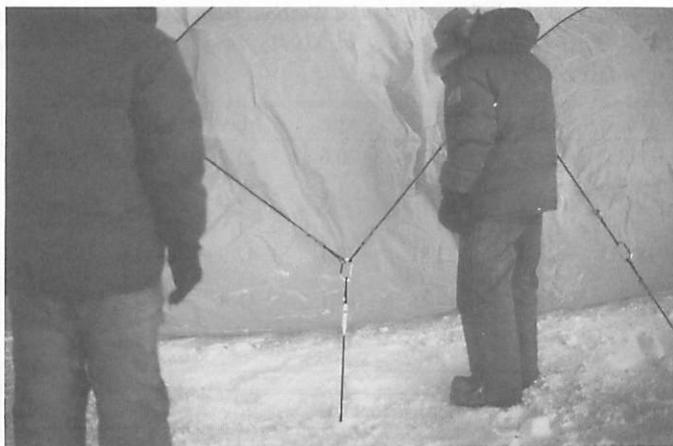
Fig. 3. Buried anchors with ropes. The guy ropes connected to the anchor ropes with carabiners keep the shape of the dome.

covered on the membrane and the ends were connected to the anchor ropes buried in the snow with carabiners (Fig. 3). A top view and schematic section of the membrane and ropes are shown in Fig. 4. The membrane was inflated by a portable ventilator (maximum air flow  $55 \text{ m}^3/\text{min}$ ) in 30 min (Fig. 5). The mean air temperature of the day (September 4, 1991) was  $-29.9^\circ\text{C}$ . After inflating the membrane, the inner air pressure was held at about 343 Pa (35 mm water head) by a vortex blower. The pressure was measured by reading a scale on a U-type pipe gage attached to the membrane.

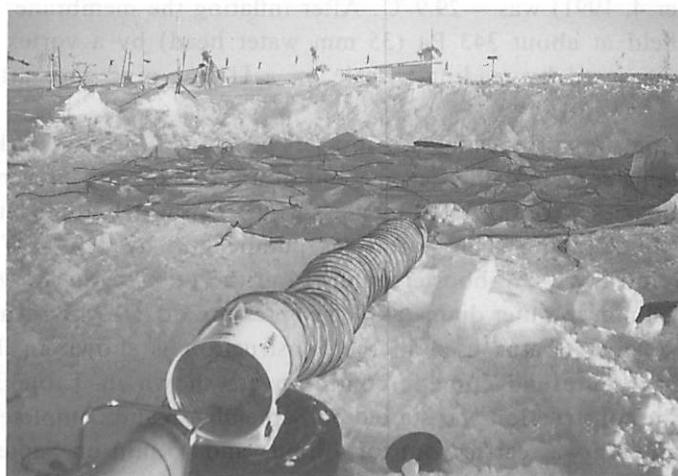
Fig. 5. Spread membrane bag with ventilator.

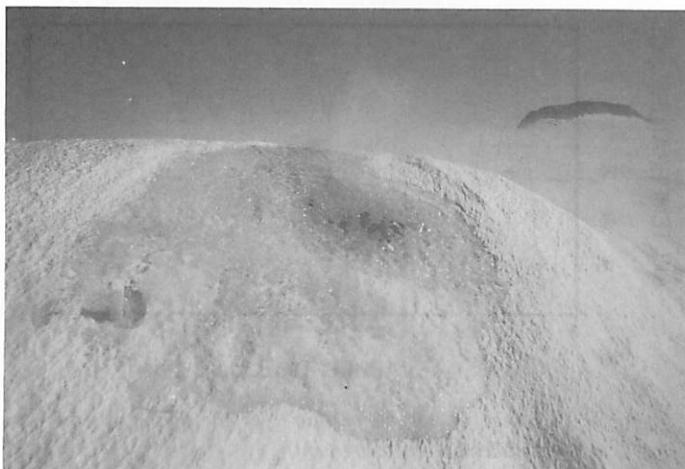
Fig. 11. Holes of the ice dome developed by sublimation in summer.

The thickness of the ice dome rapidly decreased due to sublimation in summer; consequently, small holes appeared, especially on top of the ceiling and on the north side of the ice dome. Figure 11 shows typical holes due to sublimation on another ice dome. An air pressure difference between inside and outside of the ice dome occurs on windy days; consequently, a draft mainly drained into the outside through the holes formed by sublimation. That may accelerate the development of the holes. Snow was sometimes added to the ice dome to prevent sublimation.
