CONSTRUCTION AND CREEP TEST OF 15-M SPAN ICE DOME

Tsutomu Kokawa
Professor Dr.-Eng.

Department of Architecture,
Faculty of Art and Technology,
Hokkaido Tokai University

A field study on both the construction and creep test of a 15-m span and 3.3-m rise ice dome was carried out at Hokkaido Tokai University in Asahikawa during the winter of 1986.

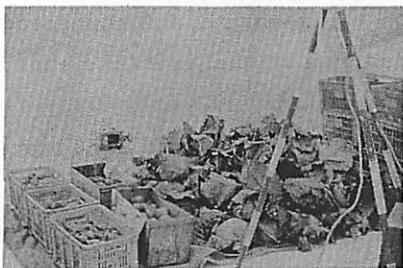
Fig.1. Storage of vegetable

On account of both the easy construction technique and high durability, 10-m span ice domes have been recently used for the winter storages of vegetables and Japanese "sake" as shown in Fig.1 and 2, at the northern parts of Hokkaido in Japan.

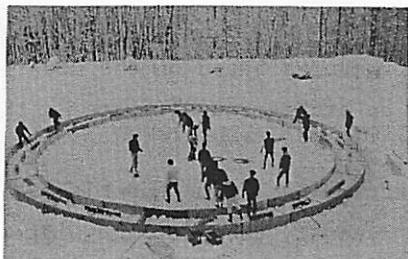
Fig.3. Foundation work

Polypropylene ropes with 12 mm diameter are lashed to the log timbers interbedded with the snow-ice foundation ring. The ring with 15 m central diameter and 45 cm × 130 cm section, is constructed by pouring snow and water into a mould made of veneers as shown in Fig.3, and treading down so as to harden and freeze the snow-ice sherbet promptly.

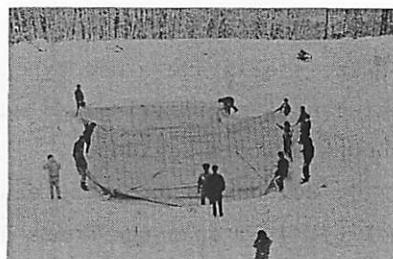
Fig.4. Placing membrane on the snow ground

A PVC membrane bag is placed on the snow ground as shown in Fig.4. This membrane bag is fabricated by welder along the periphery after wrapping in two pieces of plane sheets with 15 m diameter.

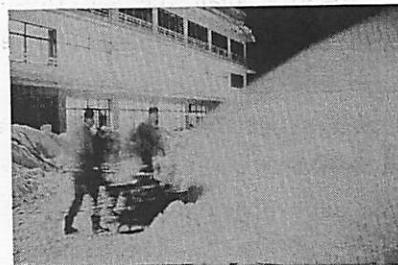
Fig.6. Snow blowing by rotary snow-plow

The space between the periphery of the membrane and the foundation is filled with snow. Snow is blown onto the membrane by a rotary snow-plow and tap water is sprayed on the snow by a high pressure adjustable nozzle, as shown in Fig.6 and 7. As a result of this operation, a snow-ice sherbet is produced on the membrane, and it is frozen hard some time later under the conditions that air temperature is below -10°C . Fig.8 shows air temperature under construction. It is necessary during one blowing operation to keep the milled snow depth to be thin. If not so, when water is sprayed, only the surface solidify and the membrane cannot keep the form because of the excessive weight which cause material and geometrical imperfections as before-reported (Kokawa,

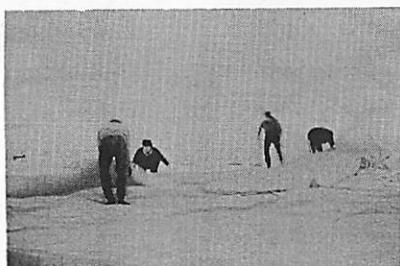
Fig. 9. Deflated membrane

The membrane bag is deflated as shown in Fig.9, and the ropes and bag for reuse are removed. The ice dome is then complete, as shown in Fig.10 and 11. The completed dome had a good quality of ice and the

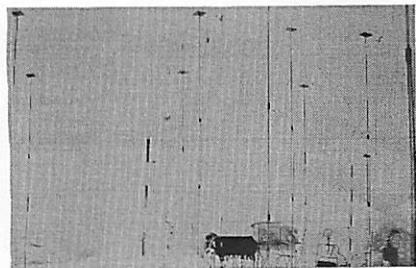
Fig.18. Inside view under creep test

All displacements, strains and temperatures were recorded automatically by a programmable data logger with 4 hours intervals from January 21 to March 19 as shown in Fig.18, exclusive of February 28 to March 5 when the data logger had gone wrong. After the automatical measurement, the structural behaviour was observed by eye up to the collapse.
