## CHALLENGE TO 20-M SPAN ICE DOME

TSUTOMU KOKAWA<sup>1</sup>, KENJI MURAKAMI<sup>2</sup>

<sup>1</sup>Department of Architecture, Faculty of Art and Technology, University of Hokkaido Tokai, Asahikawa 070, Japan

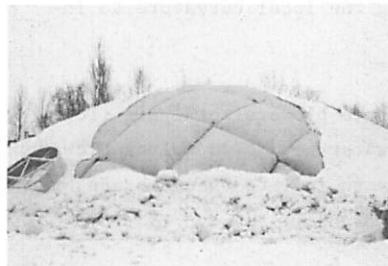
Fig.2 Removal of imperfect snow-ice at depression part

After the snow-ice froze and solidified, the membrane bag was deflated, as shown in Fig.4, and then the middle ropes and bag for reuse were removed. The construction of ice dome was then completed. However, judging from the fact that the inside light failed to transmit through the dome except the central part (3), the finish seemed to be inferior. In addition to the material imperfection at the boundary of the repaired region, both the material and geometrical imperfections were observed at another depression part including a bending crack with about 1 cm width, as shown in Fig.5.

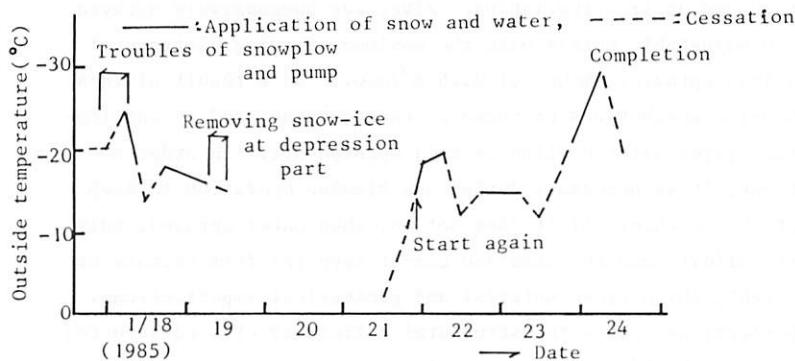
Fig.3 Outside air temperature under snow and water spraying

A milled snow was blown onto the membrane by a rotary snowplow with the maximum throwing distance 15 m and the maximum blowing quantity of 90 tons/hour, and water pumped up from the Ishikari river was successively sprayed on the snow by an adjustable nozzle with the maximum spraying distance of 20 m and the maximum spraying amount of  $0.45 \text{ m}^3/\text{min.}$ . As a result of this operation, a snow-ice sherbet was produced on the membrane, and it was frozen hard some time later after cooling by cold outside air. In order to avoid imperfections, it is necessary during one blowing operation to keep milled snow depth to be thin. If it does not so, when water sprayed, only the surface part solidify and the membrane cannot keep the form because of the excessive weight, which cause material and geometrical imperfections. Since these imperfections reduce the structural efficiency of a constructed shell, this operation should be made carefully. However, a part of the membrane was depressed suddenly because of the excessive snow-ice sherbet, under the application of snow and water before dawn in January 19. This is due to the lack of experience in snowplow operating, due to the mechanical troubles caused by the severe cold in the night of January 17. In the before noon of January 19, the snow-ice at the depression part was removed by a hammer and scoops as shown in Fig.2. After the rest for two days, the operation of snow blowing and water spraying was started again at the night in January 21, and was repeated up to the desired shell thickness during the after three nights. Fig.3 shows the outside temperature during construction.

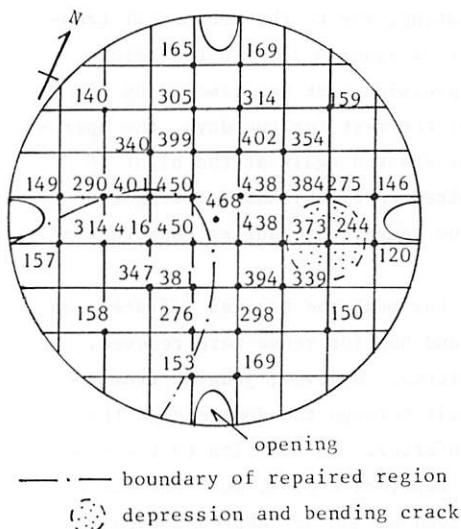
Fig.5 Heights(cm) at major points

The heights at the major inside ropes intersecting points were measured before a creep test, as shown in Fig.5. The average observed value with respect to the heights at four intersecting points near center, 4.44m, was lower than the computed height by a simplified method(3), 5.06m. The reason of this disagreement seems to be due to the prescribed depressions caused by the excessive blowing snow depth during construction.

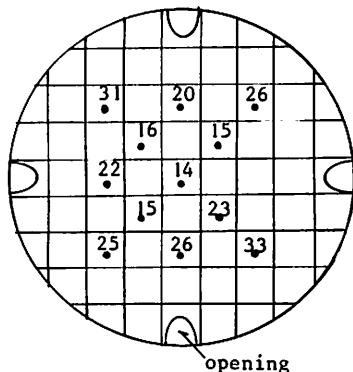
Fig.6 Thickness(cm) at major points

The distribution of the observed thickness did not become uniform because of unskilled snow blowing

during the construction, and central part was thinner than other parts, as shown in Fig.6.

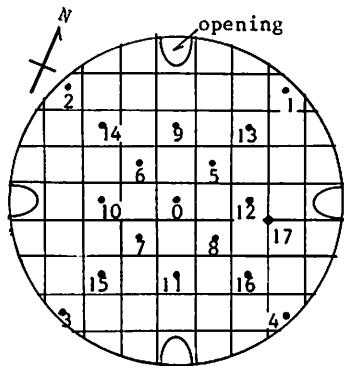
1-4;normal displacement  
0,5-17;vertical displacement

Fig.7 Numbering points for measuring displacement

As shown in Fig.7, eighteen points for measuring displacements were prepared at the inside surface of the test dome at the beginning stage. The displacement transducers were used for all points. Where the displacements of point no.5 to 17 and 0 indicate vertical displacements, and that of point no.1 to 4 indicate normal displacements. The hanging method(3) was adopted so as to measure easily the vertical displacements.

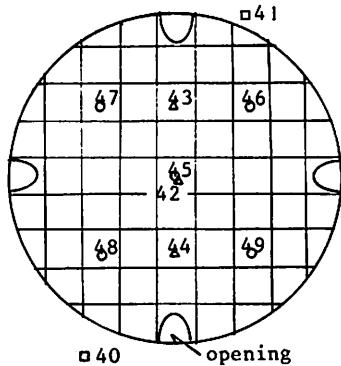
○;snow-ice temperature  
△;inside temperature  
□;outside temperature

Fig.8 Points for measuring temperature

Fig.8 shows ten points for measuring temperature at two points outside, three inside, and five snow-ice by copper-constantan thermocouples.

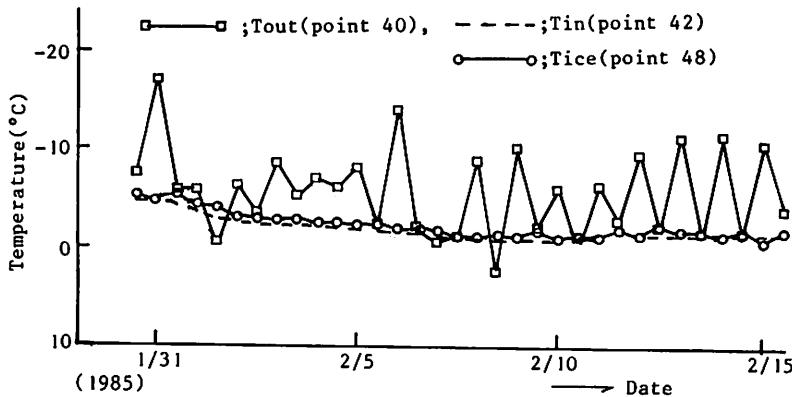
Fig.9 Temperature-time curves

it was milder than usual. Fig.9 shows three temperature-time curves. Tout, Tin and Tice indicate temperatures of outside air, inside air and snow-ice at representative points 40, 42 and 48, respectively. Under such condition that the openings are shut and dome has some snow cover in this test, Tin and Tice becomes about  $-2^{\circ}\text{C}$  independently of Tout, due to the thermal insulation effect of the snow cover and the snow-ice.

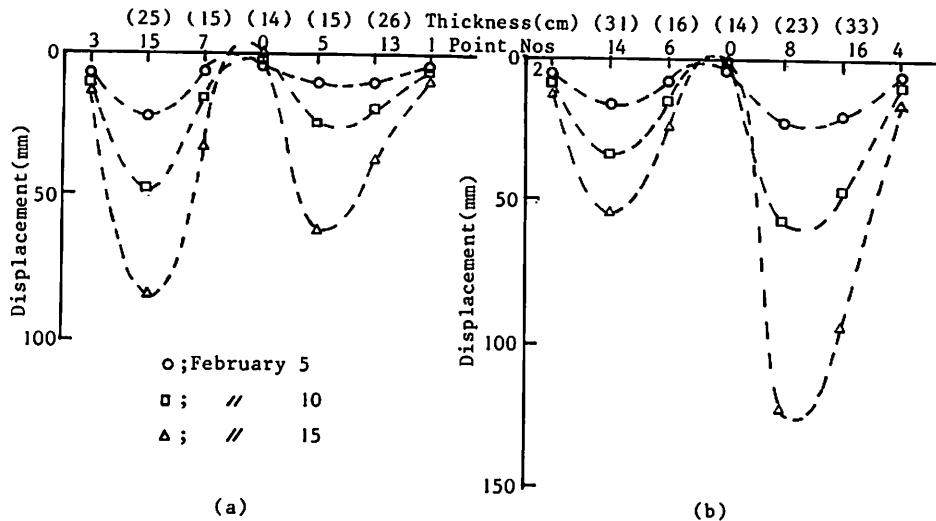
Fig.10 Deformations along two diagonal lines

Fig.10 shows the deformations along two diagonal lines in February 5,

10,15. They have preeminently symmetric third mode with respect to the center and a little assymetric mode. Taking a broad view, the deformations grow linearly with time until February 10, and then accelerates gradually because of the increase in snow-load and the geometrical nonlinearity. At the imperfection part where already the depression existed with bending crack of about 1 cm width at the completion, the width of crack was getting large and the deformation grew at an increasing rate without secondary creep stage, as shown in Fig.11. Due to the large deformation at this imperfection part shown in Fig.5, the test dome at last collapsed in February 27. The lifespan was very short than expected from the results of a creep study on 10-m span ice dome(3), and it was recognized that such an imperfection reduces steeply the structural integrity in shell. Therefore, it is important to construct ice shells without imperfections, and the blowing operation by snowplow must be carried out carefully.

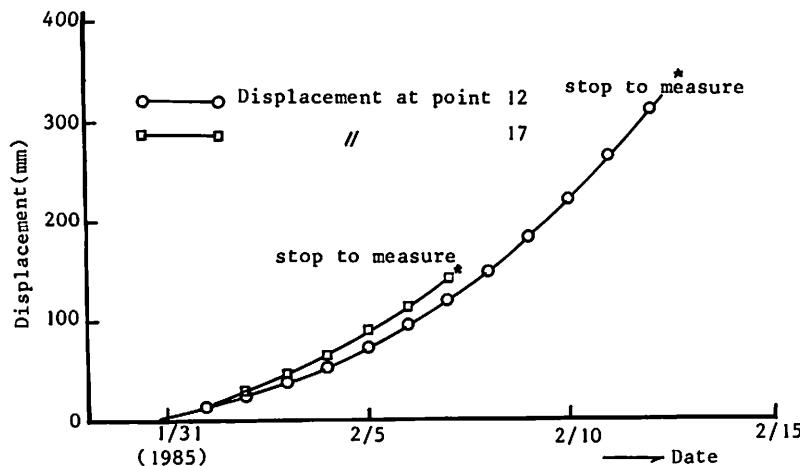
Fig.11 Displacement-time curves at depression part
