Field Experiment of Ice Dome Spanning 20~30 Meters

Tsutomu Kokawa

ABSTRACT

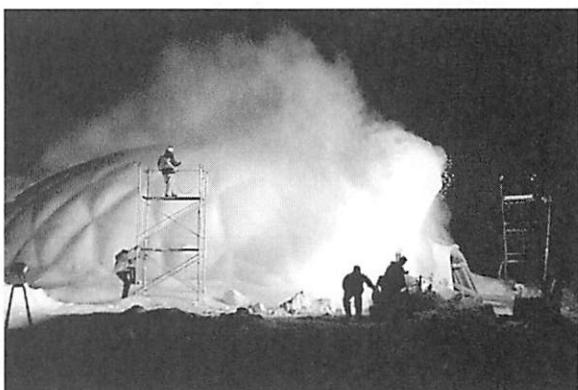
Fig. 15 Application of snow and water

polypropylene ropes were 14 mm in diameter, and their lengths were determined by spherical trigonometry. Fig. 13 shows the inflated formwork with a central height of about 9.2 m. Snow and water were applied from the evening of February 12 to the morning of February 16th (Fig. 14). Using 2 snow-blowers, each application was kept within a thickness of 1 cm. Fig. 15 shows the application of snow and water. One Φ40 hose and 6 Φ20 hoses were used for spraying water onto the milled snow. The total amount of water sprayed was 240–290 liters/min. Using the smaller hoses, water was sprayed continuously from 5 scaffolds placed around the dome. Additional water was sprayed in various places as needed, using the larger hose.

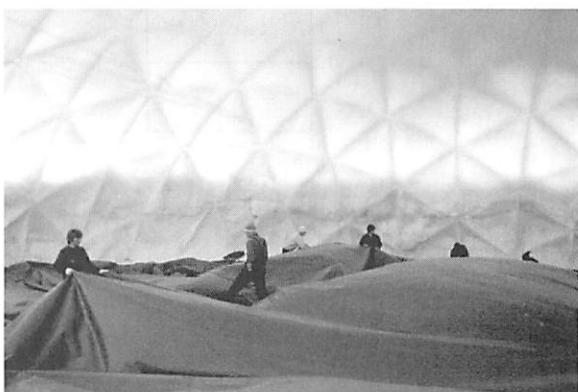
Fig. 16 Removing membrane

The deflation of the membrane bag was begun at 8 a.m. on February 16. Fig. 16 shows an inside view during the deflation. It took about 5 h, after which the membrane was folded and removed from the dome. Fig. 17 shows the exterior view of the completed ice dome.

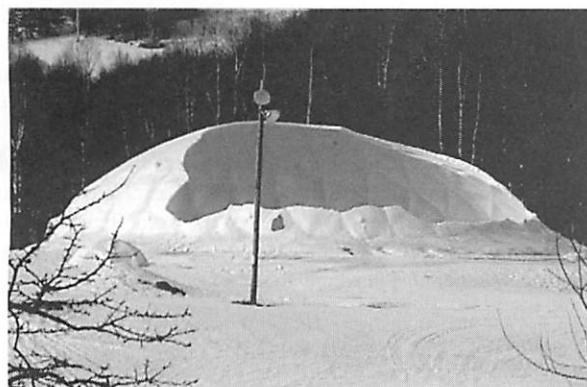
Fig. 23 Exterior view right after collapse

led to the brittle failure of the structure in this case. It is advisable to spray water and blow snow onto the dome several times even after its completion, as an easy means of maintaining the ice quality, thus improving the structural safety of the ice dome. It can be concluded that this size of ice dome will be applicable as an architectural structure during the winter season in Tomamu. A very important question is whether a 30-m-span ice dome with good-quality ice results in the brittle behavior of collapse or not. Fig. 22 shows the sequential order of the collapse. The first collapse occurred in the middle of the south side, where the sun shone strongest over the dome. The crack beside the opening of the dome did not spread enough to affect the structural behavior. Fig. 23 shows the exterior view after the second collapse.
