# FIELD STUDY OF A 30-M SPAN ICE DOME

Tsutomu Kokawa

## SUMMARY

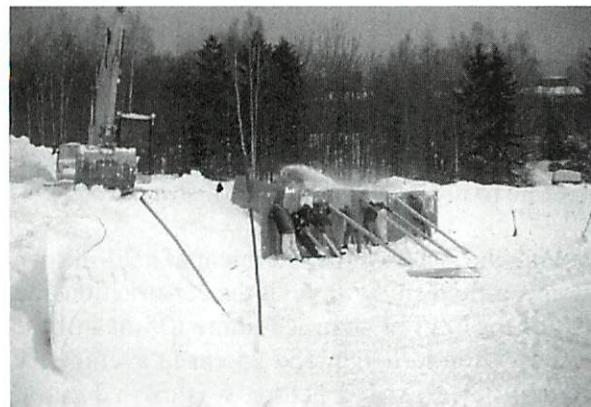
Fig. 1. Construction of snow-ice foundation ring

The construction was done from February 4th to 6th in 2001. Following the measurement and readjustment of the site on February 4th, a heavy machine as shown in Figure 1 was used for the construction of the ring with about 25 m in inner diameter. 40 rope-anchors were located equally on the inner circle and at the base, preventing the rise in dome from excessive height caused by the 5 % elongation of the P.P. rope.

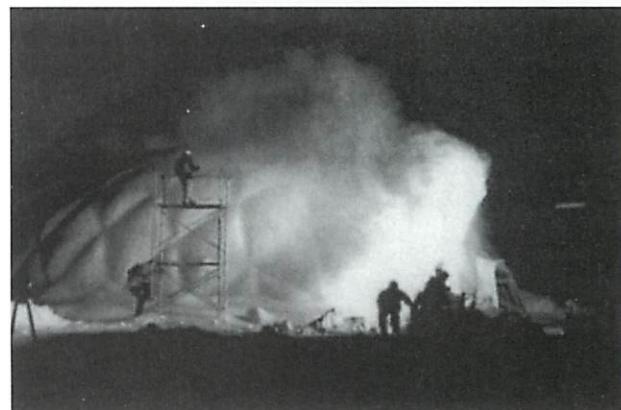
Fig. 7. Application of snow and water

Application of snow and water was carried out from February 12th evening to 16th early morning. As shown in Figure 6, it was very nice weather to construct ice shells at that period. Figure 7 shows the situation under construction. A  $\phi 40$  hose and six  $\phi 20$  hoses were used for spraying water onto the milled snow. Total amount of spraying water was  $240 - 290 \text{ litter/min.}$ . It is assumed that the  $\phi 40$  hose normally supplied  $150-200 \text{ litter/min.}$   $\phi 20$  hoses were continuously operated on five high stages, and  $\phi 40$  hose was intermittently used moving around the dome according the situation. On the other hand, blowing the milled snow onto the membrane was carefully done by two snowplows so as to keep the snow thickness less

than 1 cm during one operation. The one with the capacity of 22 m maximum throwing distances was used for blowing the snow except the vicinity of the apex. The other with 30 m throwing distances was applied in case of the central parts of the dome. It is assumed that the thickness of the completed dome was approximately 25 cm in average. It took 2 hours to get 1 cm ice thickness in this experiment because it needed 56 hours in total time for the application of snow and water.
