RE-CHALLENGE TO 20-M SPAN ICE DOME

ABSTRACT

A large ice shell with spans from 20 m to 30 m has not yet been utilized as an architectural structure for lack of the reliability on its construction technique and structural safety. This paper describes the construction experiment and creep behavior of the year 2000' test-dome, and concludes, that a 20-m span ice dome is possible to use as an architectural structure during winter in Tomamu, Hokkaido.

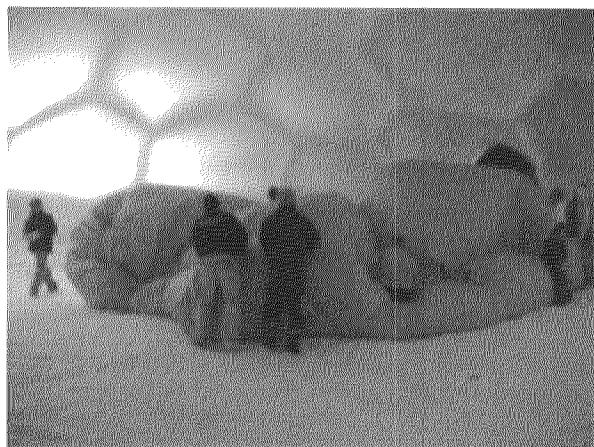
Fig.5 Removing membrane

It was 4 a.m. on February 8th when the application of snow and water was finished and then the membrane started immediately to deflate. The inside space was quite huge compared with human scale and gave a feeling of space never experienced before. Fig.5 shows the situation of removing the membrane after deflation.
